January 9, 1996

## ***Issue Alert Letter #10***

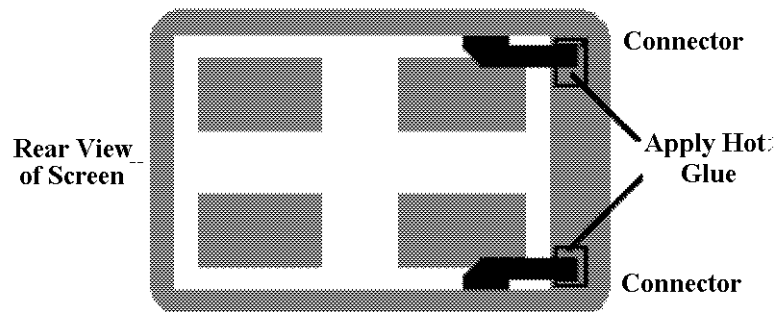
A failure has been reported on the T21xxCS and SP400CS systems where either the top or bottom half of the internal screen remains blank (no display image appears). This problem occurs when one or both of the ribbon cable connectors on the rear of the screen becomes loose and lifts up from the PC board connector. This failure is unique to the Sharp screens used on the CS models of the T21xx and SP400 series products.

The problem was eliminated by Sharp in October when they replaced the push-on connectors with a snap-in version. However, prior to the connector change, Sharp attempted to resolve this problem by gluing the connectors to the PCB. Unfortunately, the type of glue used did not bond well on the PCB surface.

We have found that the LCD panels can be repaired by removing the old glue and securing each connector with a single bead from a hot glue gun.

We would prefer that Service Providers use a replacement LCD panel to repair these units so that the bad screens can be sent to Sharp for connector replacement. However, we realize that in some cases Service Providers may need to repair these units in the field. Where this is the case, care must be taken to apply glue only to the outside edge of the connector, away from the contact pins. In addition, only hot glue should be used. The use of epoxy or other permanent bonding agents will void the manufacturer's warranty on the panel.
